Penicuik Heritage Regeneration

The Restoration and Enhancement of Penicuik Town Hall

This is a leaflet to mark the completion of the restoration and enhancement scheme, explaining why it was carried out and what was involved.

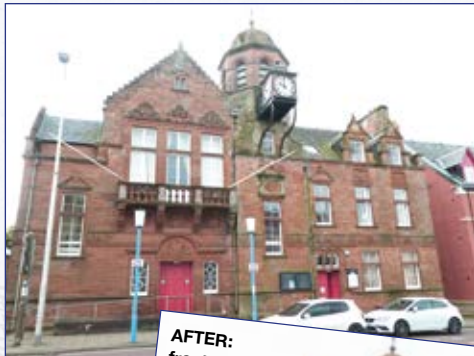
BEFORE:
front elevation

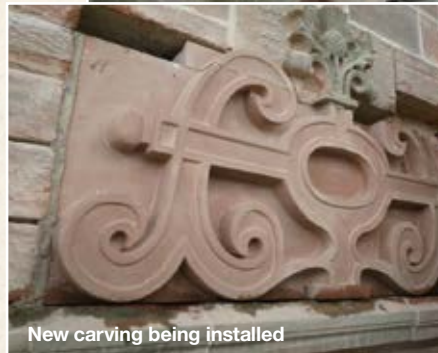
New carving being installed

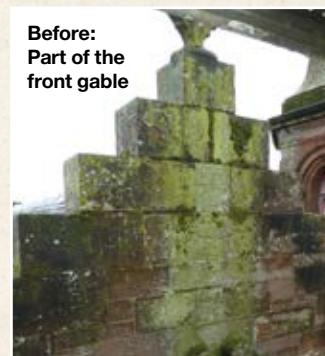
Before:
Part of the
front gable

Moss, lichen and vegetation growth has been removed from the stonework using a benign water based solution to avoid damage to the sandstone.

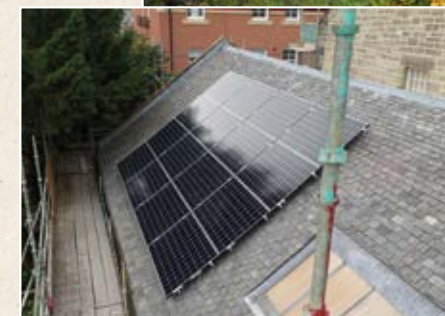
Rear roof from above, re slated and photovoltaic panels installed

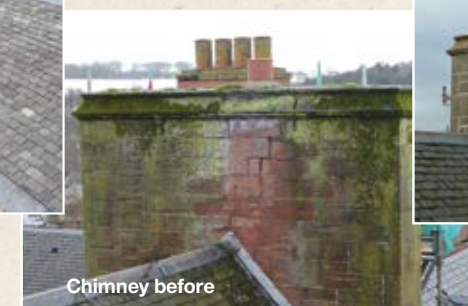
Chimney before

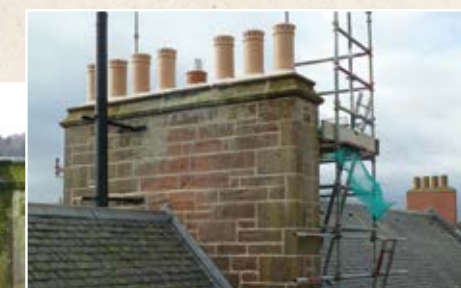
Chimney restored, repointed and with new CHP flue

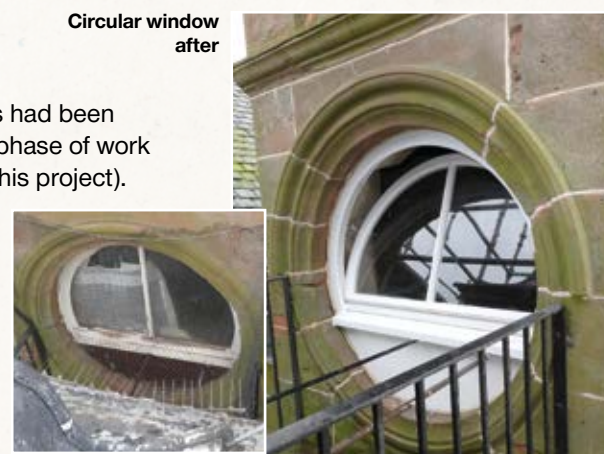
Circular window
after

Circular window
before

Most of the windows had been replaced in the first phase of work (not grant aided by this project). There were a few however which were not and were replaced with new timber windows to match the originals.

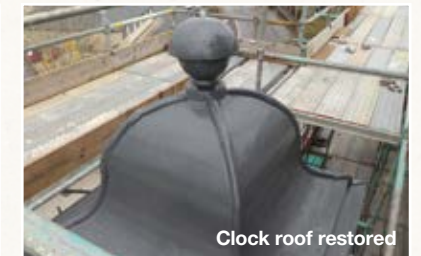
Clock roof restored

The clock had been restored as part of previous work but some restoration was carried out as part of this scheme.

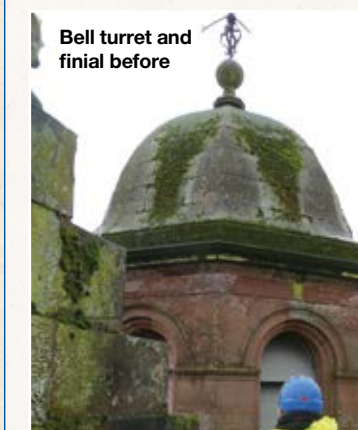
Bell turret and
finial before
