## HISTORIC BUILDING MAINTENANCE AND REPAIR GUIDE

### What is the Penicuik Heritage Regeneration Scheme?

The Penicuik Heritage Regeneration Scheme is a partnership between Midlothian Council, the Heritage Lottery Fund and Historic Environment Scotland, supported by the Penicuik Community Development Trust, Penicuik First and other community organisations.

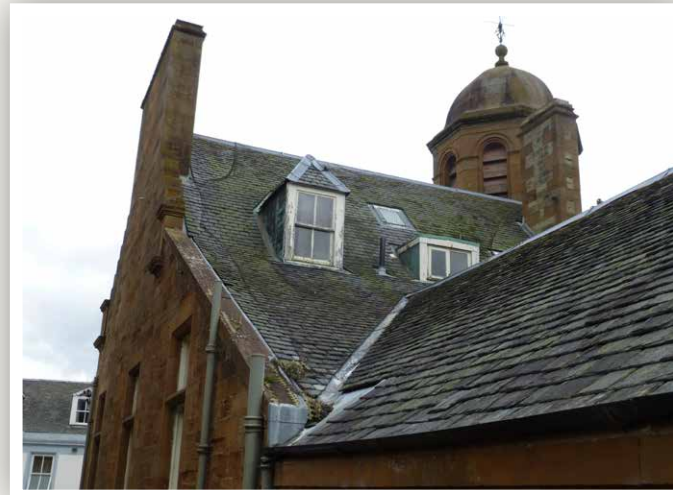
## Roofs and Roof Coverings

Pitched roofs are constructed of rafters, ceiling ties (beams), struts and wall plates and all should be in good condition. Regular inspections are recommended because if damp and unventilated conditions exist, fungal attack can result. Dry rot is particularly damaging. Insect attack can also weaken timber structural members. If roof timbers need treating for dry rot, expert assessment is needed so that non-destructive methods and non-toxic applications can be used wherever possible. The spraying of roofs and other timbers as a precautionary measure is of little value. In many cases the prevention of further water entry and the alteration of the internal conditions by, for example, increasing natural ventilation, may be sufficient to halt timber decay. Specialist contractors should undertake this work.

Roof coverings are mainly in natural Scots and Welsh slate. This gives a distinctive character and texture to roofs which no substitute, such as concrete tiles can replicate. The replacement of slate with modern materials can be particularly damaging and disruptive to the appearance of the town. When repairing and reroofing attempts should be made to source Scots and Welsh slate where required to match existing. Missing, slipped or broken slates should be promptly replaced to match the original in order to avoid roof leaks. Flat roofs were traditionally covered with lead sheet on superior buildings, or zinc for more general use. Surviving examples are

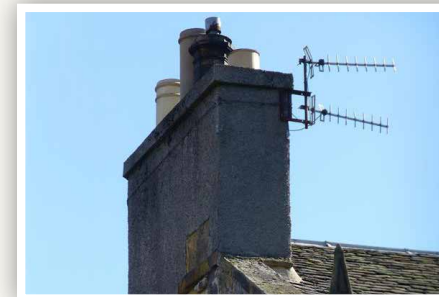
## Chimneys and Skews

Chimney stacks (called 'stalks'), are the parts of the building most vulnerable for weathering, being exposed on all faces.

Chimney stalks are usually built in fairface rubble masonry but are often rendered with cement where the stone has decayed. The junction between chimney stalk and roof is a weak point in the roof covering and any deterioration of the lead flashings or cement fillets here should be repaired promptly.

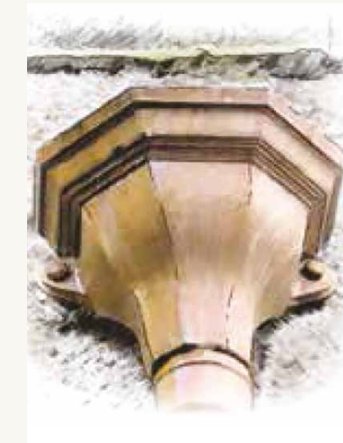
## Rainwater Goods

Rainwater goods includes, rhones (gutters), hoppers, brackets downpipes and shoes at the foot. Cast iron was traditionally used because of its durability. If properly maintained these elements have a long life.

Cast iron must be painted to prevent deterioration and all joints between the various parts should be watertight. Rhones should be cleaned out annually to remove dirt and leaves and all cast iron should be repainted when existing coating start to deteriorate and in any case at approximately five-yearly intervals. Replacing cast iron with other materials such as upvc or aluminium is strongly discouraged. Modern substitutes may have different profiles and different fixings and supports. PVC is affected by ultraviolet light and is likely to change colour and become brittle with age, and is susceptible to physical damage and cracking.

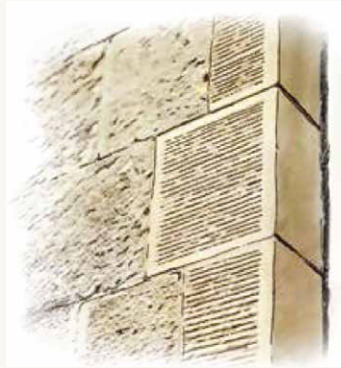
Traditional masonry walls were built with two 'skins' of stone and the core filled with broken stone, lime mortar waste and rubble. The outer layer or face was either random rubble to take a harl or smooth lime render, or ashlar (stone blocks with a smooth or textured face, built with fine joints).

The inner stone was rubble with wider joints, also built with lime mortar. To the inner face was fixed horizontal timber laths to take two or three coats of lime plaster. The cavity between the laths and the stone face served to allow air movement and the evaporation of any moisture in the wall.

Prior to about 1900 masonry walls were constructed without damp proof courses. The 'breathability' of natural materials - stone, lime mortar and lime plaster is sufficient to control moisture and allows both ingress and evaporation.

To prevent water entering the top of the wall a sound, dry and well ventilated roof was essential. Moisture in the base of the walls can be reduced by lowering of ground levels, improved drainage around the building, replacement of any hard cement mortar with lime mortar and if none exists, the introduction of underfloor ventilation. Modern injected damp proof courses are of little value in traditional masonry walls of composite construction as described above, and the appearance of the masonry wall can be spoilt by lines of drilled holes, both horizontal and vertical.

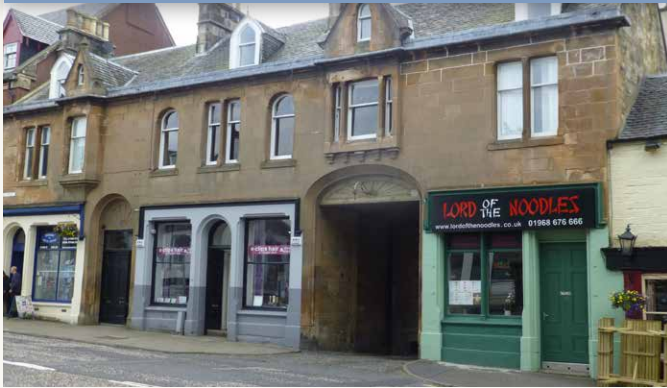
Shop Fronts

Shop fronts in the historic part of Penicuik tended to be of two types. Some of the buildings traditionally had the shop name and signage hand painted on the stone string course running at first floor level. Shop windows were vertical narrow windows often with low cill heights.
